The Road Inventory of Lost Trail National Wildlife Refuge Marion, MT

Prepared By:
Federal Highway Administration
Central Federal Lands Highway Division
August 2008

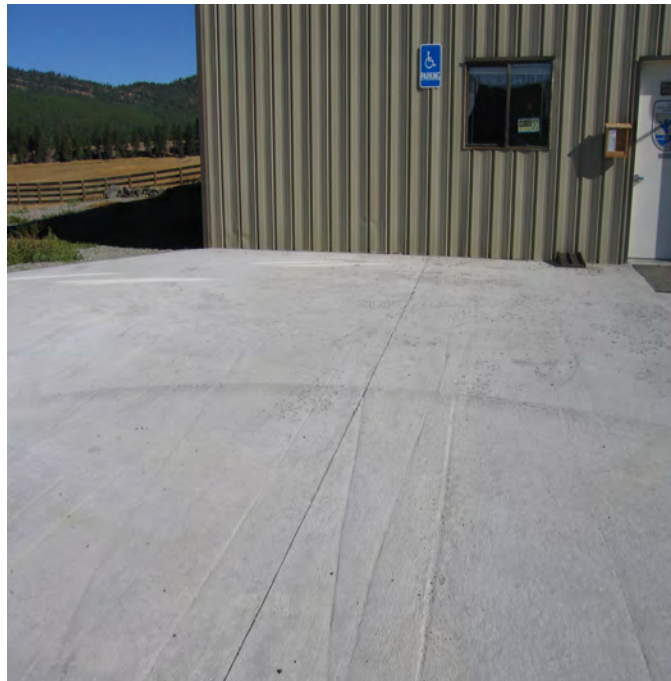
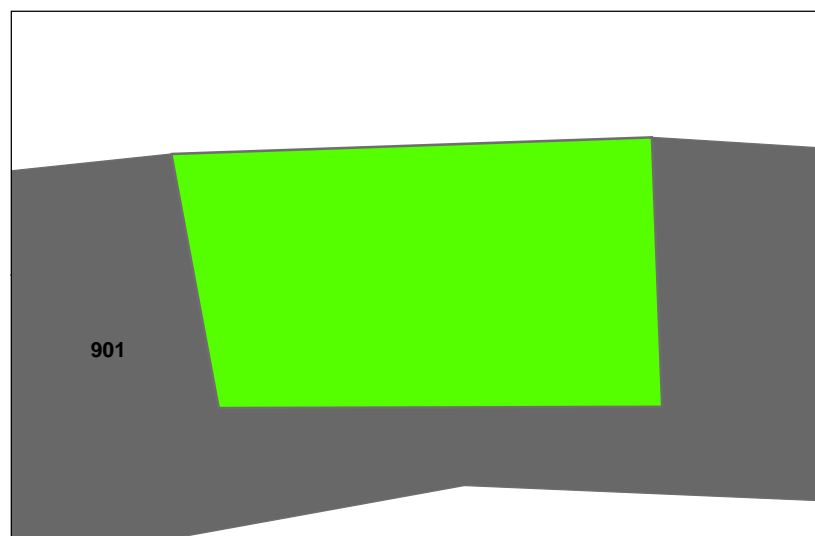
Route 904: HQ/VC Handicap Parking

Asset Number	Date Visited	Surface Type	Area (sq ft)	Condition	Cost to Improve
	8/22/2008	Concrete	612	Good	\$100

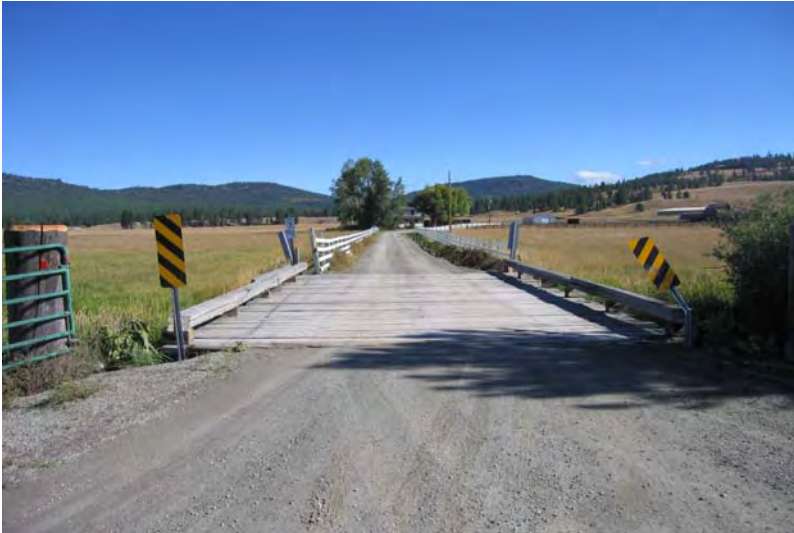
Lost Trail National Wildlife Refuge Bridge Inventory					
Rte #	Milepost	NBIS #	Sufficiency Rating	Functionally Obsolete	Structurally Deficient
010	0.01	61545-52532	45.6	No	No

Photo # 2067 - MP 0.01 - Bridge
